Preliminary Excavation Directors
Report
Central Station Main Works
March 2020

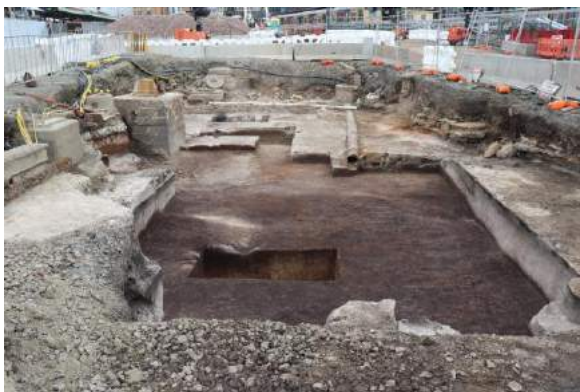
Figure 3: Stage 1 open area investigation

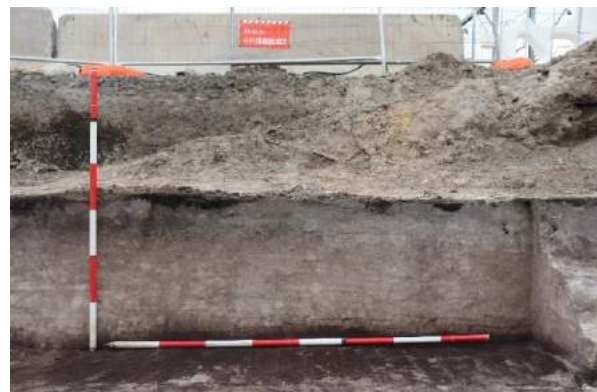
Figure 4: Profile of upper intact dune deposit with presence of Aboriginal objects

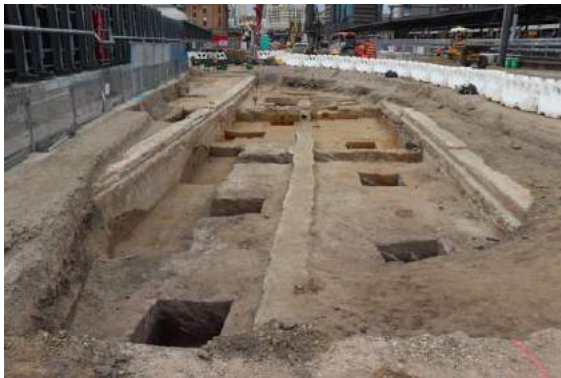
Figure 7: View north of Test Excavation Area 2

Sand deposits were identified during monitoring of machine excavation to clear the overlying fill, which triggered test excavation requirements. A total of 22 (1m by 1m) Aboriginal archaeological test pits were excavated in Test Excavation Area 2. The test pits varied in depth between 300mm and 1m. The upper stratigraphic units of the majority of the test pits comprised of a redeposited (residual) natural sand which abruptly transitioned to an intact basal dune profile. The redeposited sands are associated with the Devonshire Street Cemetery and formed part of the fill material between the pedestrian ('Y') tunnel and the Devonshire Street Tunnel (DST) (see section 2.3.3).⁶

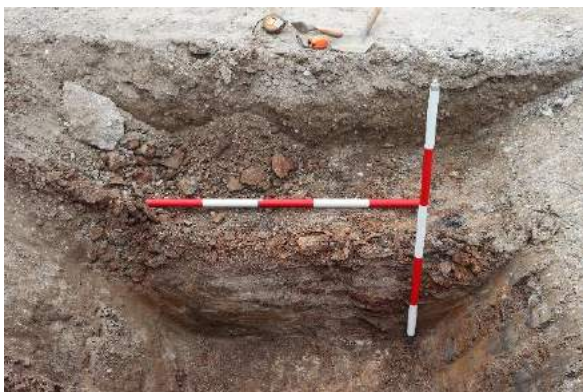
Figure 9: Test pit location north of 'Y' tunnel showing the shale profile

Twelve of the sixteen test pits were located between the northern most boundary of the site and the southern branch of the 'Y' tunnel. It was found that this area contained an upper stratigraphic unit comprised of modern fill overlaying the natural basal clays and shale. No significant archaeological features or intact artefact bearing deposits were identified in these locations and therefore no salvage was triggered.

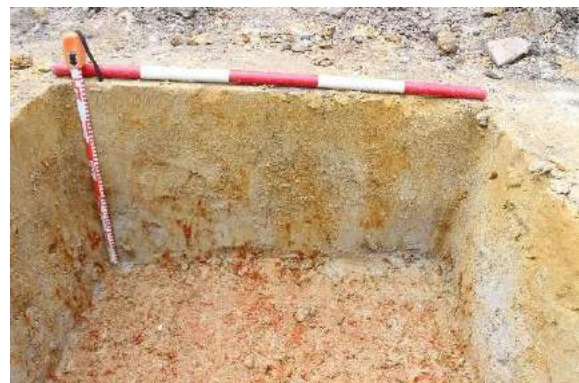
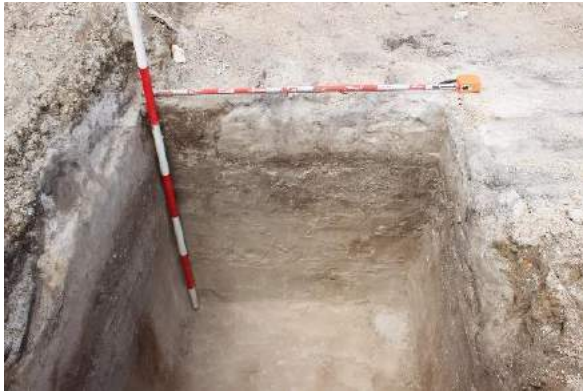
Figure 10: Test pit location south of DST showing the basal dune

The four remaining test pit locations were situated south of the DST. Following initial machine clearance conducted under archaeological supervision, intact sand dune was identified at all four locations. In each location, a 1m by 1m test pit was hand excavated in 100mm stratigraphic units (spits). The southernmost test pit comprised of the lower portion of intact dune (basal dune) and contained no Aboriginal artefacts (Figure 10). This supported the findings in Test Excavation Area 2 that the basal dune is a sterile stratigraphic unit. The remaining three test pits contained the upper stratigraphic unit of the dune as evidenced by fine grey sand similar to that found in Test/Salvage Excavation Area 1 (Figure 11). One Aboriginal artefact was located within the intact sand profile of a test pit containing the intact upper stratigraphic sequence of the sand dune.

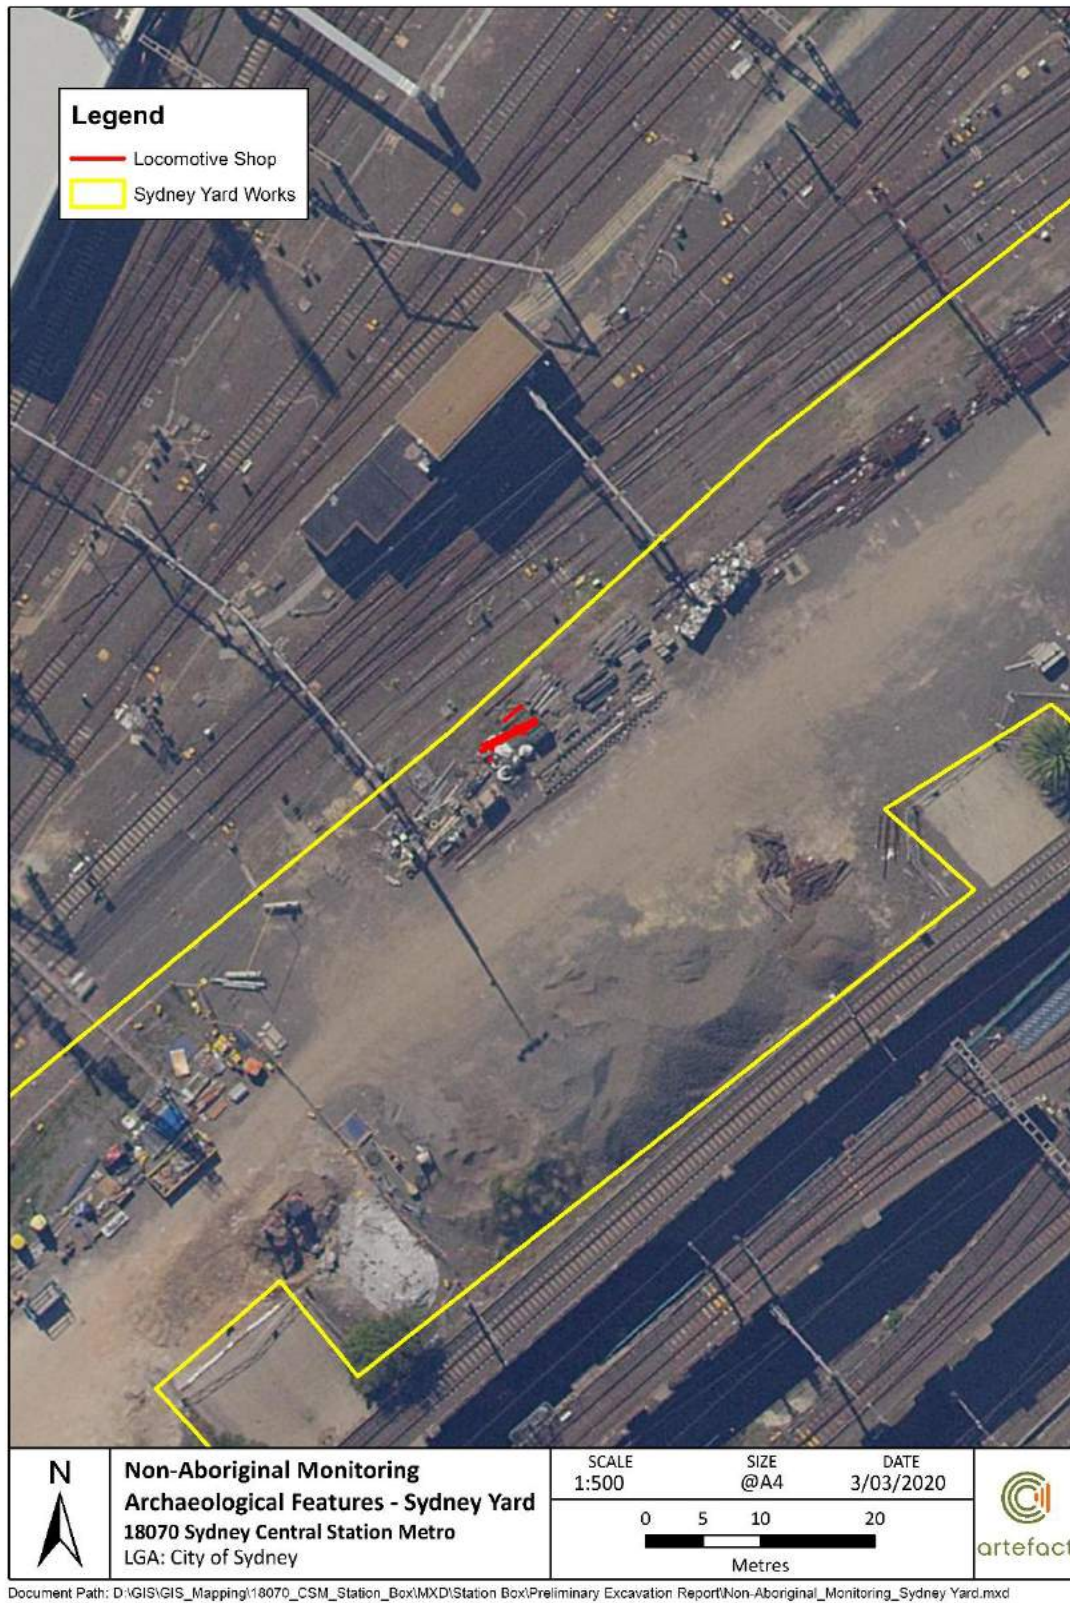
Figure 14: Location of non-Aboriginal archaeology monitoring program (south)

This section provides the results of the archaeological monitoring program for non-Aboriginal Archaeology. Figure 13 and Figure 14 shows the findings from the monitoring archaeological program.

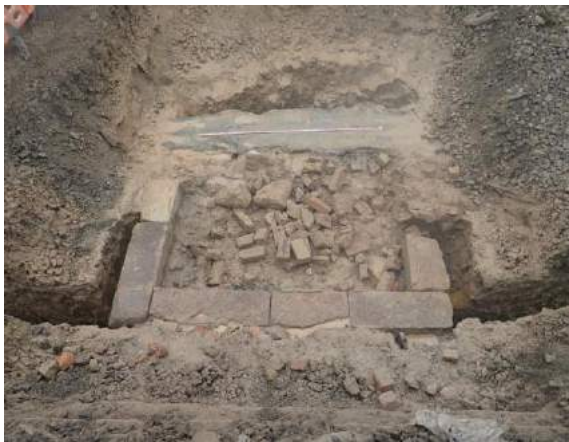
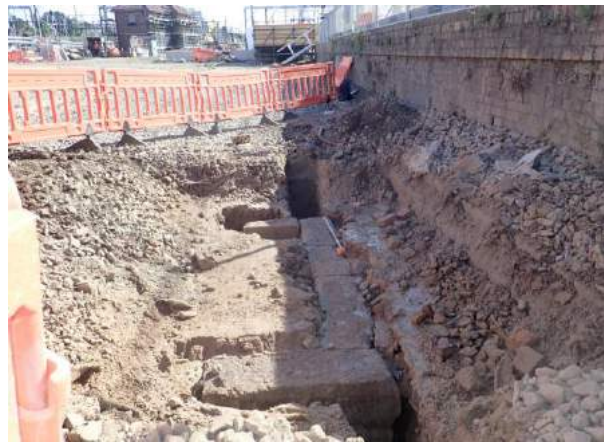
Figure 15: Monitoring shot of burial vault located within the former Devonshire Street Cemetery

On 13 November 2018, a rectilinear sandstone feature was uncovered during monitoring of NDD (Figure 15 - Figure 16). The visible remains were 2.9m by 2.5m and had been significantly impacted by a concrete service feature on the eastern wall. The structure was located within the former Devonshire Street Cemetery and had the potential to be a burial vault. The feature was later investigated as part of the Devonshire Street Cemetery salvage program (see section 3.3.7).

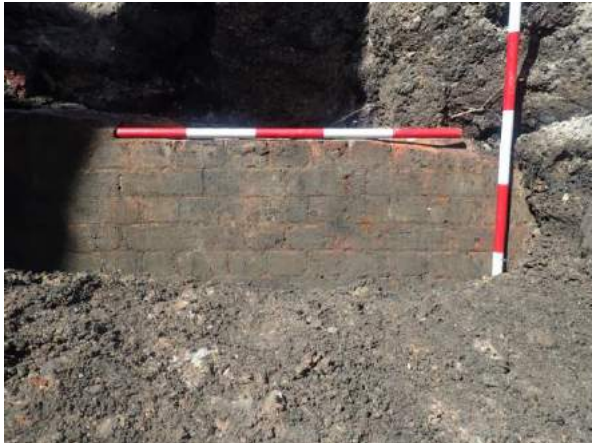
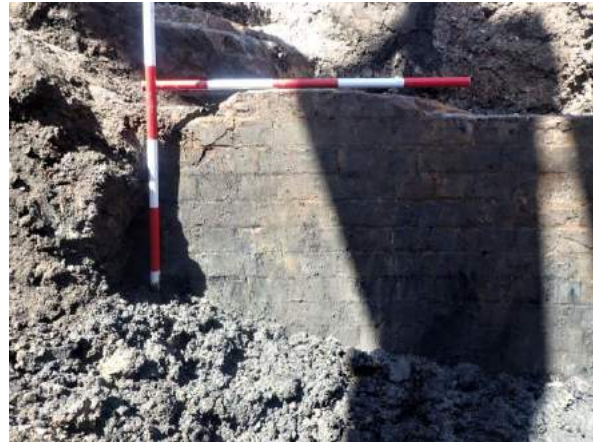
Figure 17: Section of curved brick wall associated with the former Gasworks uncovered during monitoring works

Following its identification, the feature was further exposed and recorded. Direct access to the feature was limited due to the contaminated nature of the fill within the former gasworks and therefore remote recording was undertaken.

Following archaeological recording, the portions of the gas holder that were exposed were removed for the construction of the station box. The western portion of the gasworks remains *in situ*.

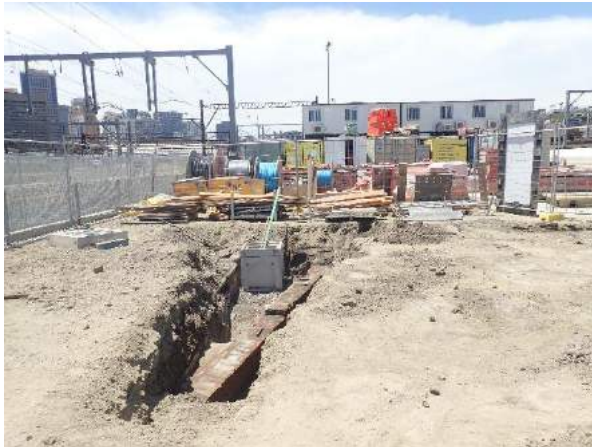
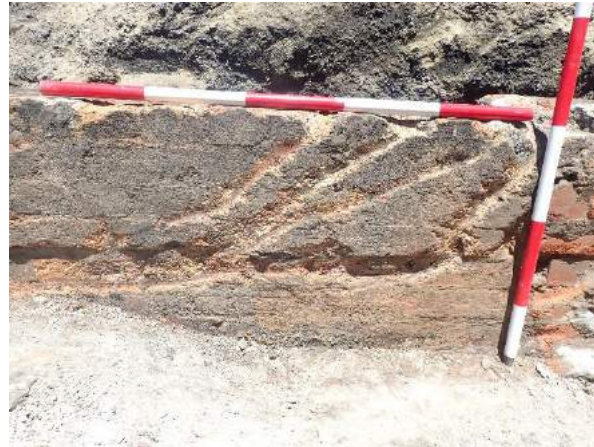
Figure 21: Portion of Locomotive Shop uncovered during monitoring

A portion of an intact brick wall was uncovered during NDD works in the south yard on the alignment of proposed stormwater drainage on 31 January 2019 (Figure 21 and Figure 22). The NDD trench was subsequently expanded by machine under archaeological supervision. The brick wall was confirmed to be remains of the Locomotive Workshop. A new stormwater drainage route was designed to avoid impact to the remains, and they were retained *in situ*.

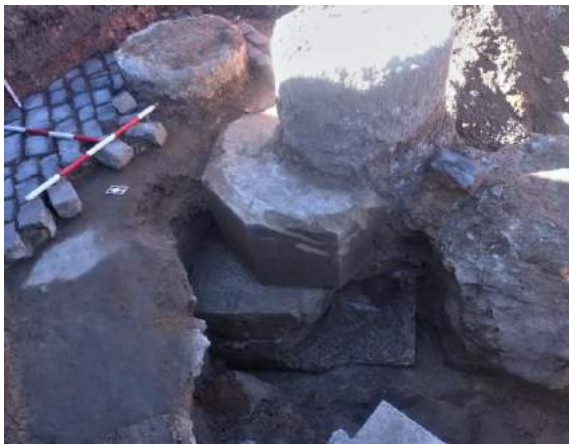
Figure 23: Image showing octagonal sandstone gatepost, basalt cobblestone surface and modern piling disturbance.

On 15 June 2019, two stacked sandstone blocks were uncovered during monitoring for piling works south of the DST (**Figure 23**). Historical research and mapping indicated that this sandstone structure was likely to be a gatepost, associated with the former entrance from Devonshire Street into the Sydney Yard. One of the sandstone blocks had been cut into an octagonal shape whilst the sandstone foundation, on which the octagonal block was resting, was irregular and roughly cut (Figure 24). Both sandstone blocks were constructed on a cement base. Adjacent to the sandstone gatepost, a north-east to south-west running basalt cobblestone surface was uncovered. On the 15 June 2019 a number of loose basalt cobblestones were found within close proximity to the gatepost, whilst the *in situ* remains of the cobblestone surface were identified between 29 June and 2 July 2019 (**Figure 25** and Figure 26). In total the cobblestone surface spanned an area of 1.2m by 2.7m. The remains were archaeologically recorded and removed in accordance with the AMS.¹⁰

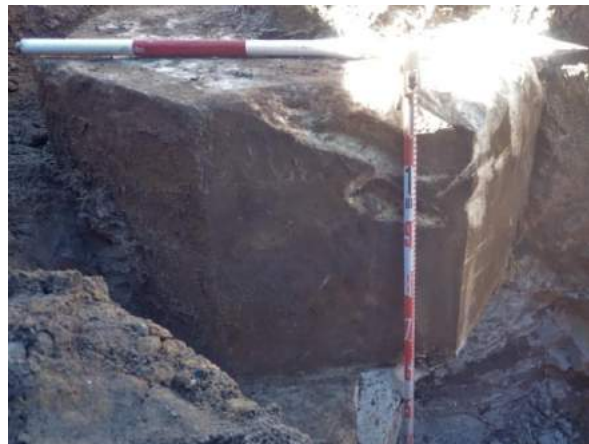
Figure 24: Octagonal sandstone block uncovered during monitoring

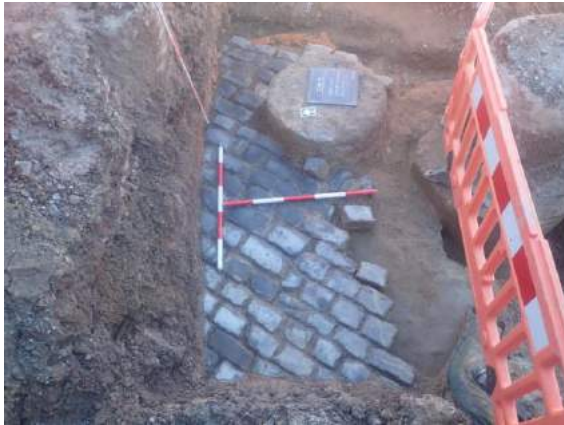
Figure 25: Basalt cobblestone surface uncovered during monitoring

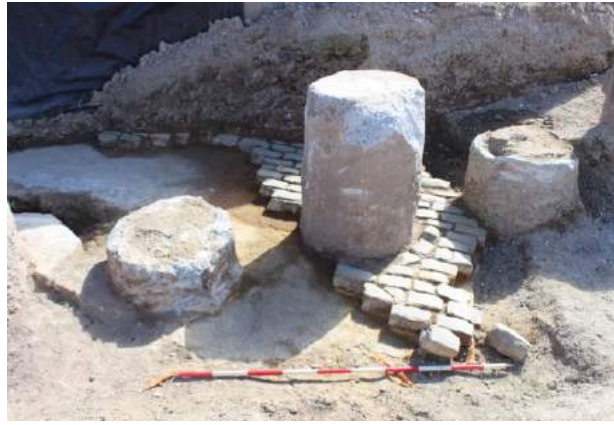
Figure 26: Additional section of basalt cobblestone surface

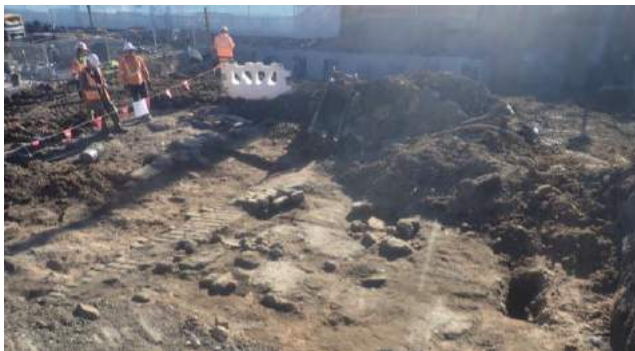
Figure 27: Monitoring shot showing basalt cobblestone surface

An additional section of cobblestones was uncovered on 17 August 2019. The cobblestones, which were irregular, had been significantly disturbed (Figure 27). Historical research and mapping indicated that this surface was associated with the original alignment of Devonshire Street. The basalt cobblestone surface was identified again on 22 August 2019, which triggered a program of archaeological salvage. The basalt cobblestone surface covered an area of 3.5m by 1m and was heavily disturbed; replaced by a basalt rubble fill in some areas.

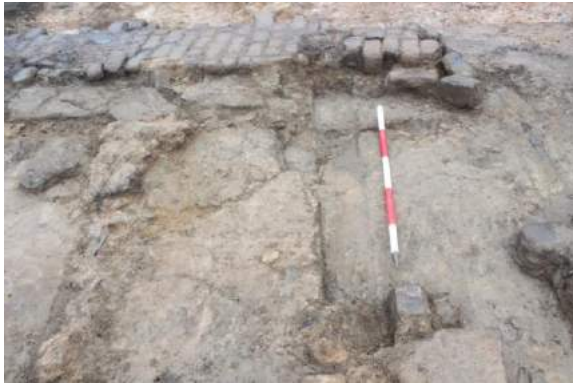
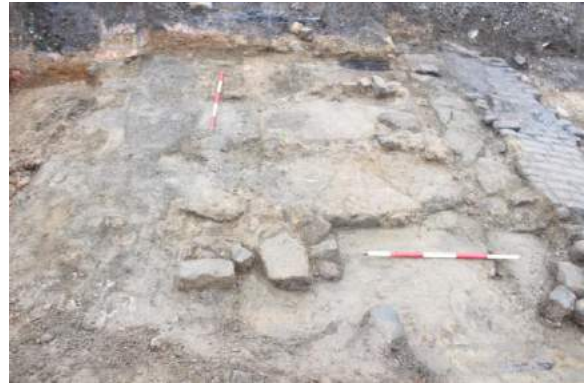
Figure 28: View of basalt cobblestone surface and tram track indentations within cement

Directly adjacent to the basalt cobblestone surface, a number of east-west running indentations were identified. The indentations were consistent in size and distance apart and remains of wooden sleepers and a section of metal rail were also present. Historical research and mapping indicated that these indentations were associated with the former Devonshire Street tram tracks.

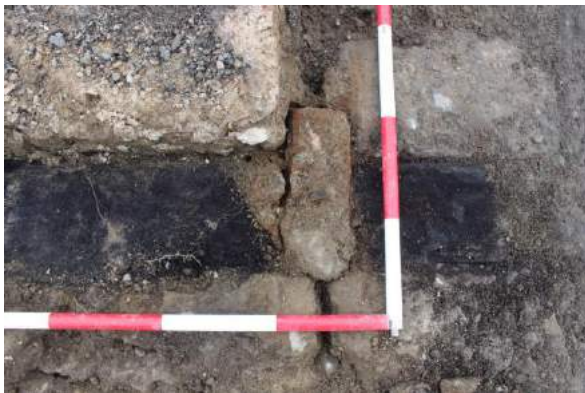
Figure 30: Detail shot of wooden sleeper and metal tram track

Adjacent to the cobbled entrance were a number of indentations set into a concrete base similar in composition to the base found under the cobbles. These indentations were consistent in distance apart; running roughly north- south with a gradual curve to the west. Some of the indentations contained preserved wooden sleepers. Historical research and mapping indicate that the indentations were associated with tram tracks leading into/from Sydney Yard. The sleepers had a width of approximately 200mm and height of 90-100mm; however, the average length of each track was undetermined due to disturbance.

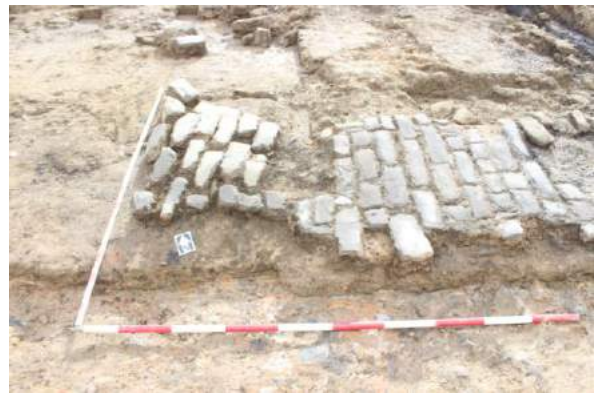
Figure 31: Detail shot of basalt cobblestone surface

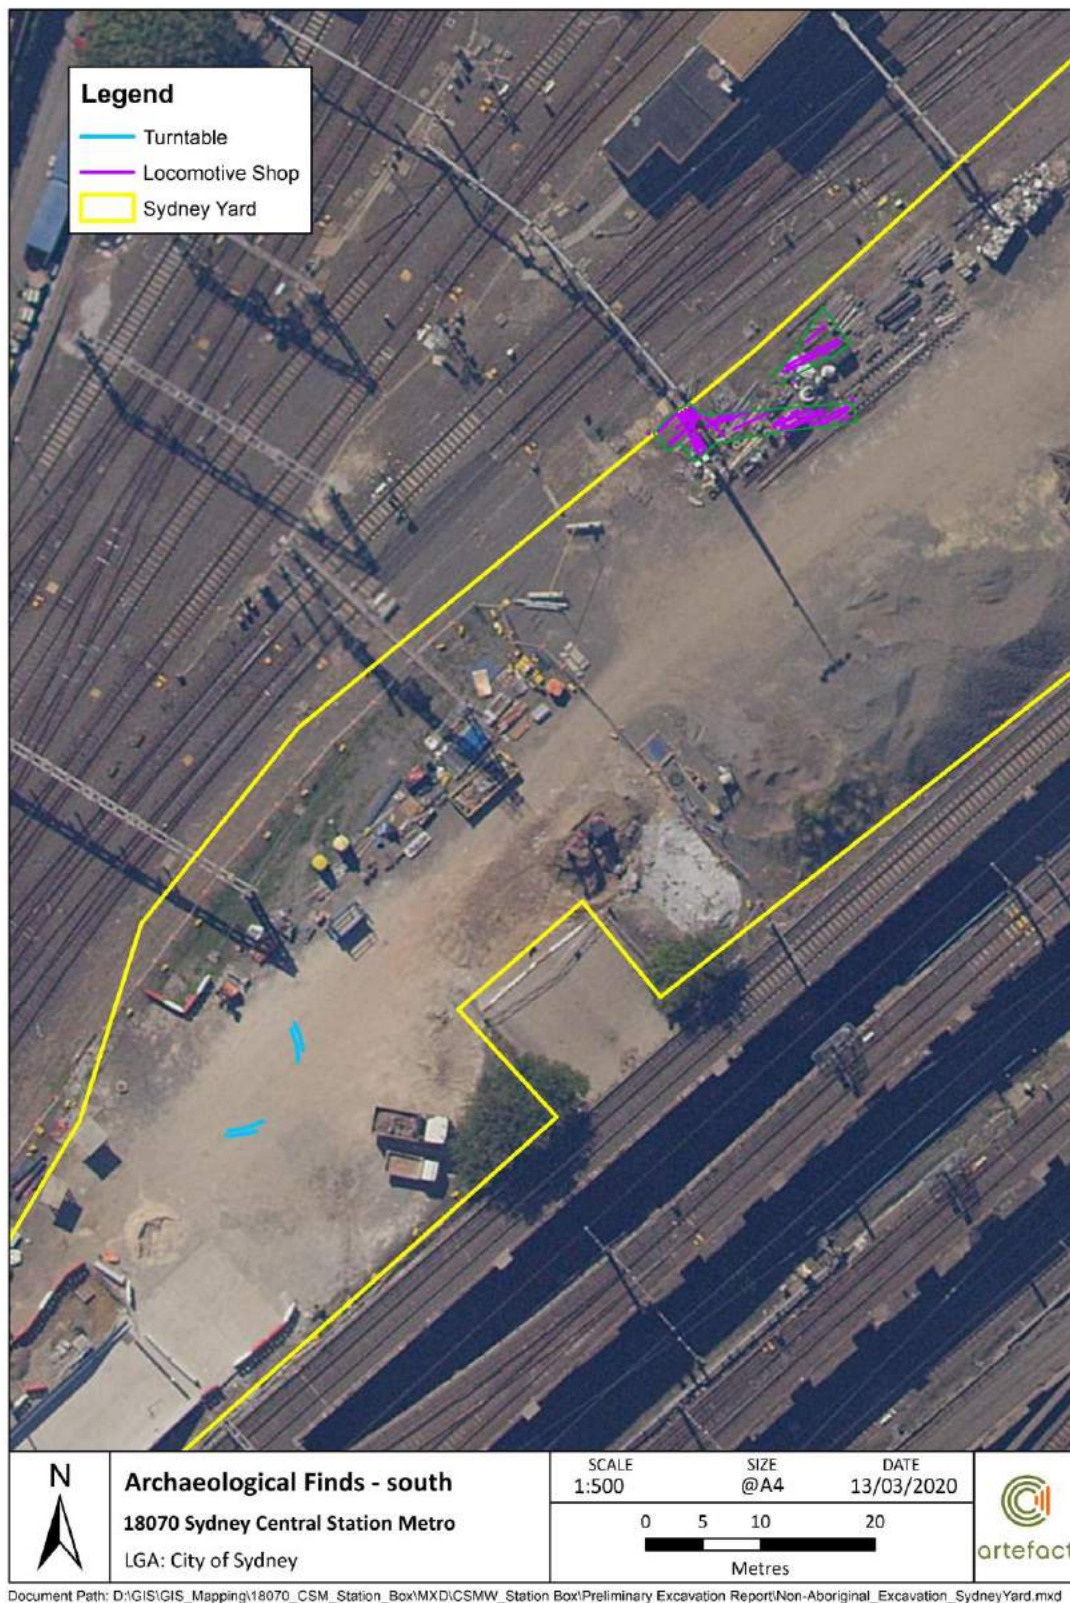
Figure 33: Location of non-Aboriginal archaeology excavation program (south)

Figure 32 and Figure 33 shows the findings of the test/salvage archaeological program.

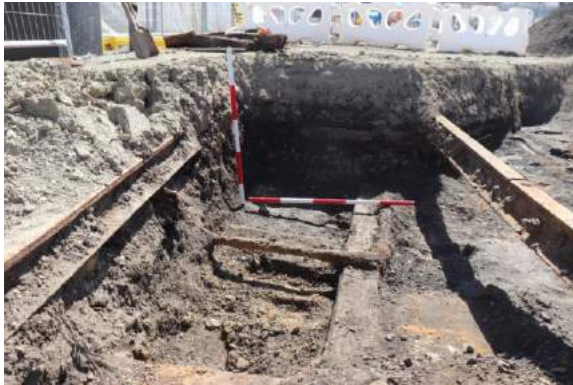
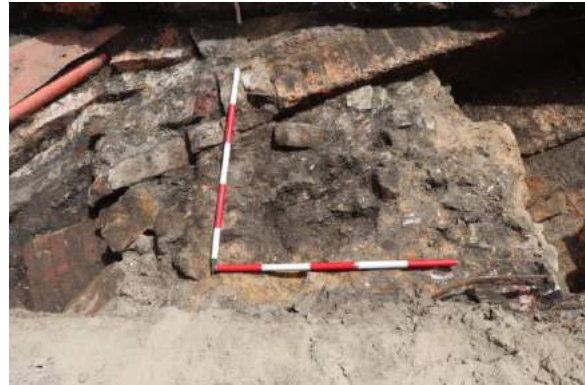
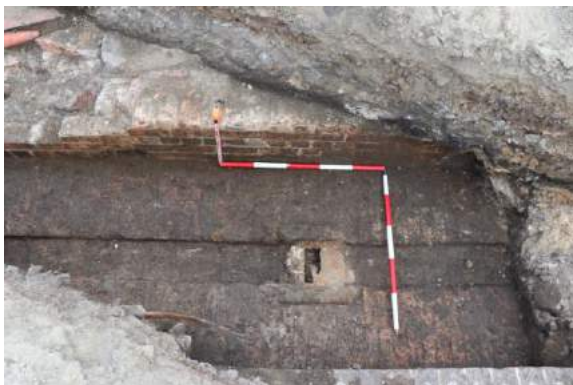
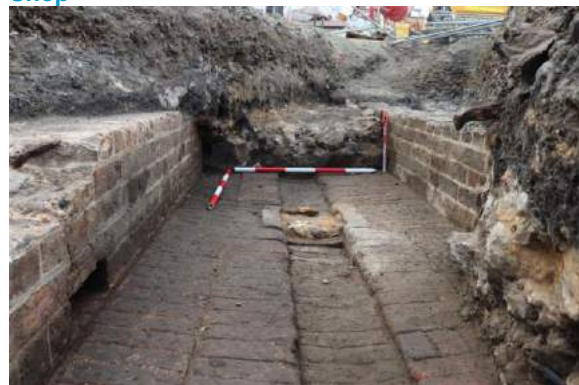
Figure 34: View of Locomotive Shop

The Locomotive Shop brick walls were found to run north-east to south-west and conform to the orientation of the Locomotive Workshop as shown in historical mapping. Several sandstone blocks set into the natural basal clay at the southern extent of the feature, running south-east to north-west, and perpendicular to the brick walls. These sandstone blocks may represent footings from an earlier structure, or an ad-hoc support for later development.

Stormwater works were abandoned in this location therefore no further investigation was required. The structural remains of the excavated extent of the Locomotive Shop were not impacted and were left *in situ* and are not anticipated to be further disturbed by future works.

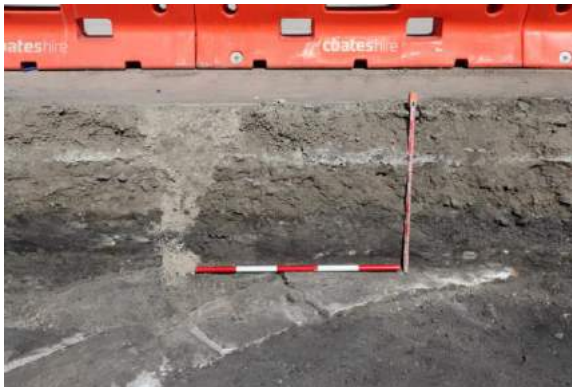
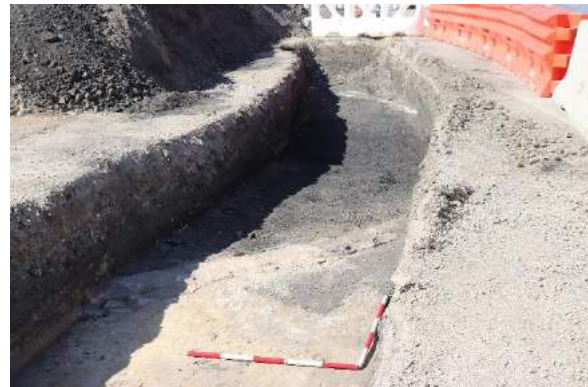
Figure 38: Detail shot of sandstone blocks within turntable

Archaeological test excavations identified the remains of the first turntable constructed in the Sydney Yard. Stormwater works were abandoned in this location therefore no further investigation was required. The structural remains of the excavated extent of the turntable were not impacted and were left *in situ* and are not anticipated to be further disturbed by future works.

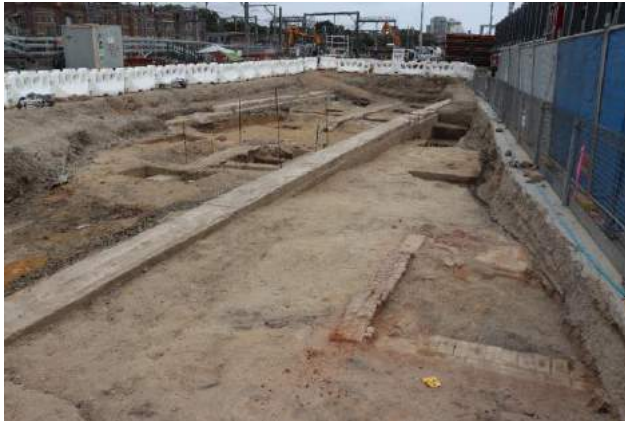
Figure 42: View south of Test Excavation Area 2 showing Burial Vault 2 (right), remnant wall of platform 13 (centre), burial vault 1 (left)

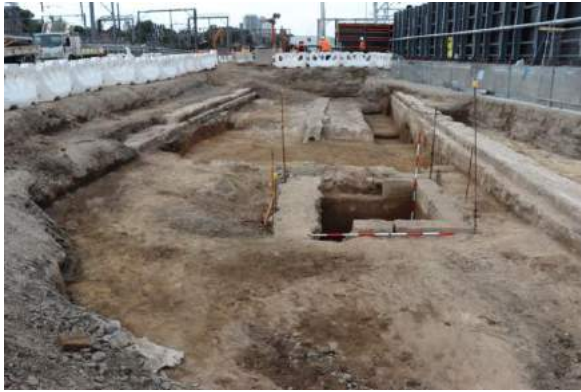
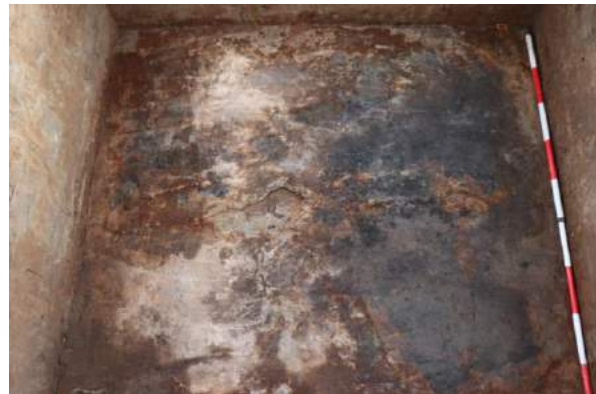
Figure 43: Context shot of burial vault within the former Congregational Cemetery

Figure 46: View within burial vault following coffin remains removal

The deposits within the burial vault reflected four phases of infilling: natural silting, post exhumation phase decay, exhumation and demolition. Within the decay deposit, the remains of three north-south facing adult hexagonal coffins were uncovered. The coffins were well preserved and found in situ on the base of the vault with a variety of intact coffin furnishings found including nails, decorative brass studs, iron handles and cloth lining. In addition, an abundance of poorly preserved human bone was present which included teeth, and hand and foot bones. The quantity and nature of the bone indicated that prior to exhumation, there would have been several additional coffins within the burial vault, as infant and juvenile bones were present.

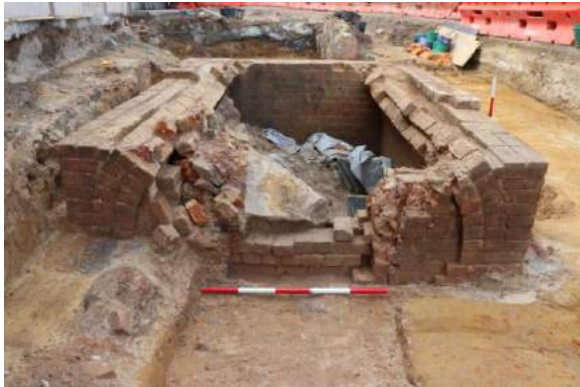
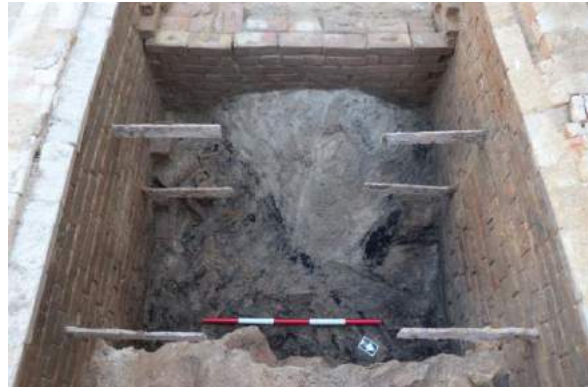
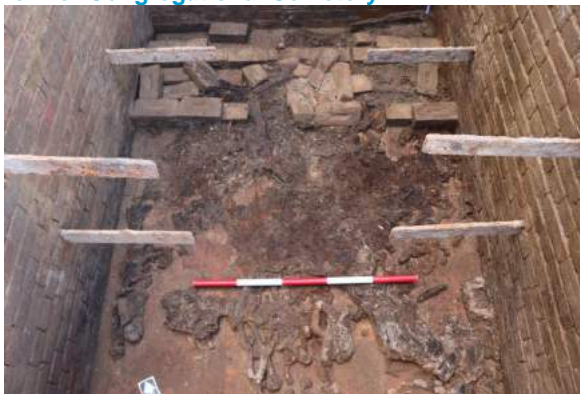
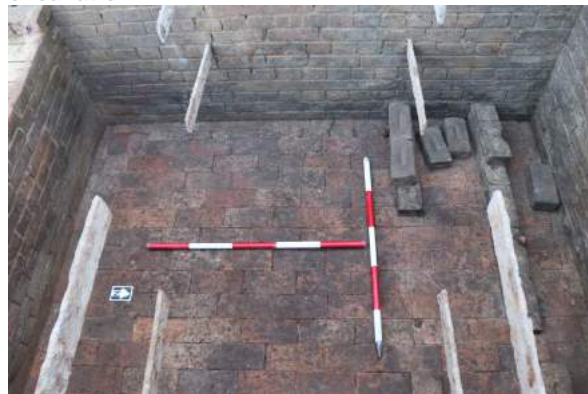
Figure 47: Context shot of burial vault within the former Congregational Cemetery

Figure 48: Shot showing burial vault during excavation

Figure 49: Shot showing coffin remains within the burial vault

Figure 50: View within burial vault following coffin remains removal

Eight iron brackets were found built into the vault walls, designed to hold coffins. Two parallel rows of bricks, two courses high, were bonded to the floor against the northern wall of the vault, interpreted as an additional coffin shelf.

The deposits within the burial vault reflected four phases of infilling: post exhumation phase decay, exhumation, re-silting and demolition. The decay deposit was represented as a spread of coffin and fragmented human remains across the base of the vault. There was an abundance of coffin furnishings present including coffin nails, bronze tacks, handles, and fragments of a name plate. Human bones were small and degraded with a partial skull and feet bones identified. Lastly, a gold ring with abstract floral design was uncovered.

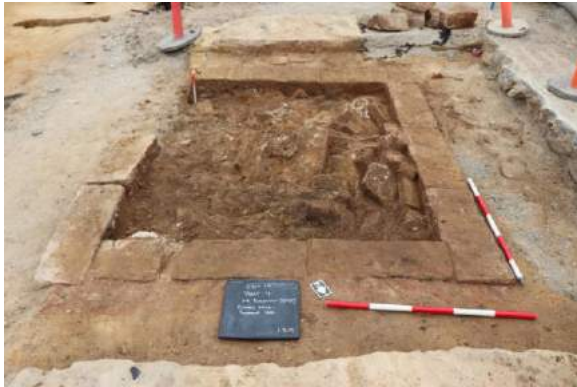
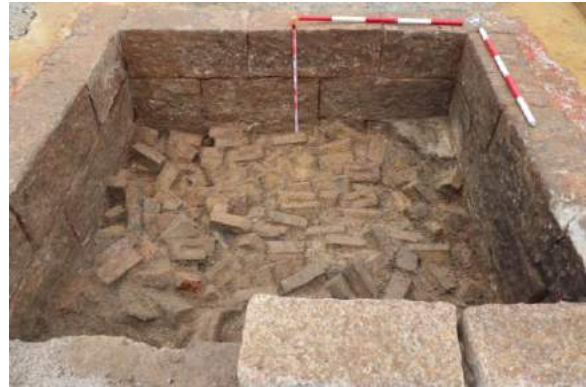
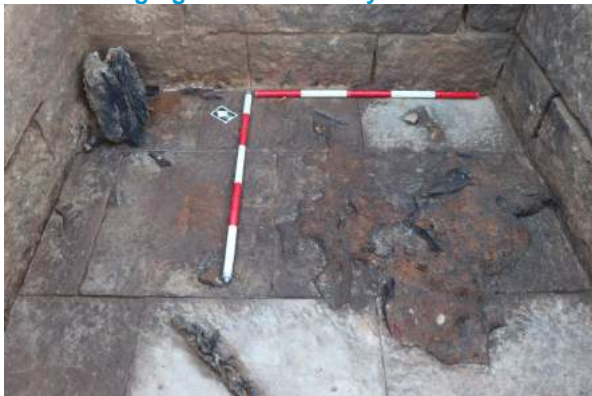
Figure 51: Context shot of burial vault within the former Congregational Cemetery

Figure 52: Shot showing burial vault during excavation

Figure 53: Shot showing coffin remains within the burial vault

The vault had been impacted during the construction of Platform 14, during which time a single sandstone block had been removed.

The deposits within the burial vault reflected three phases of infilling: decay, exhumation and demolition. The decay deposit was represented as a spread of coffin and disarticulated human remains across the base of the vault. Within this deposit an abundance of coffin timber fragments, iron coffin nails and handles were found along with a small number of bone and teeth.

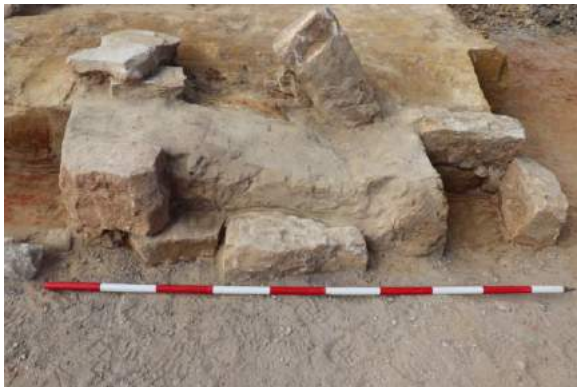
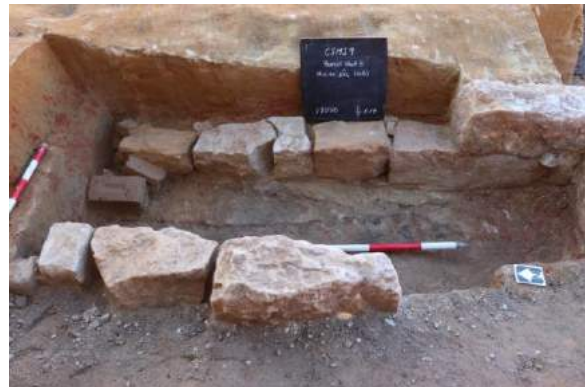
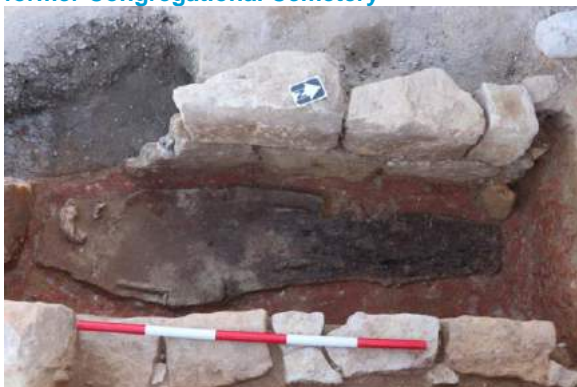
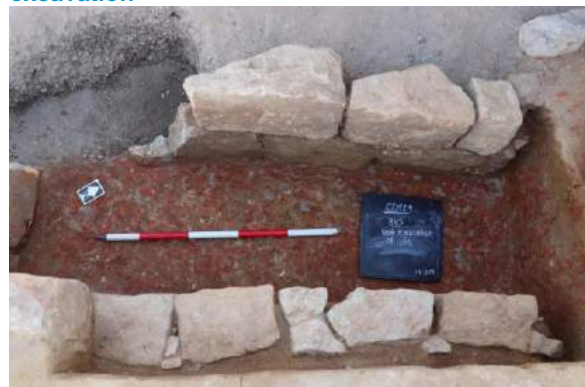
Figure 54: Context shot of burial vault within the former Congregational Cemetery

Figure 55: Shot showing burial vault during excavation

Figure 56: Shot showing coffin remains within the burial vault

Figure 57: View within burial vault following coffin remains removal

The structure was well preserved despite being impacted by the construction of Platform 14, which had disturbed or removed only a small number of sandstone blocks.

The sandstone-lined grave contained the north-south aligned poorly preserved remains of an undisturbed burial. Remains included a coffin base with iron coffin nails, and human bone including right and left femurs, right humerus, skull and teeth.

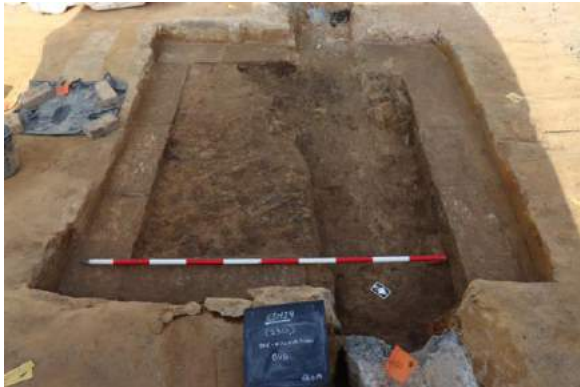
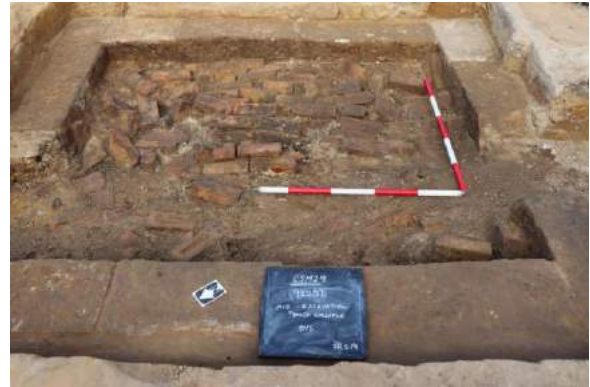
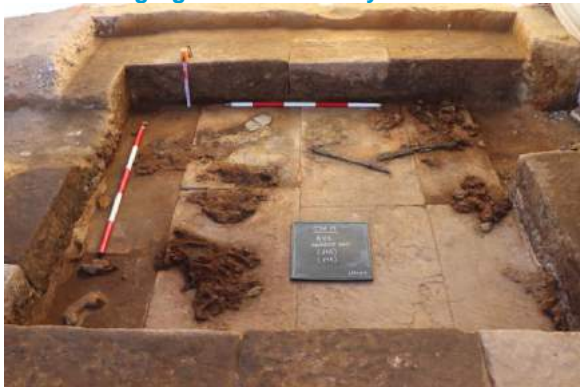
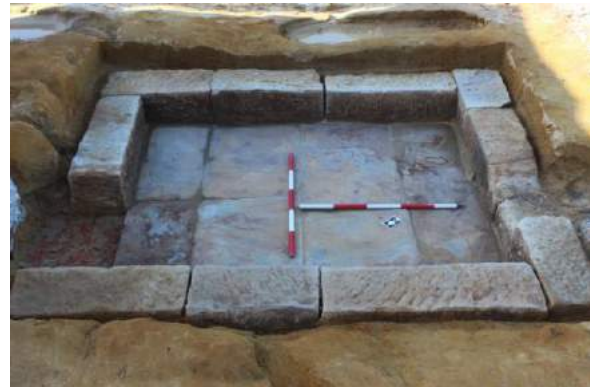
Figure 58: Context shot of burial vault within the former Congregational Cemetery

Figure 59: Shot showing burial vault during excavation

Figure 60: Shot showing coffin remains within the burial vault

Figure 61: View within burial vault following coffin remains removal

Only one course of sandstone blocks remained and at a total depth of 0.37m, the structure visible during excavation was not deep enough to contain intact coffin remains. The structure was partially disturbed by a concrete service which ran directly through its centre.

The deposits within the burial vault reflected three phases of infilling: decay, exhumation and demolition. The decay deposit was represented by a spread of coffin and human remains across the vault floors. Remains included coffin timber, small bone fragments, buttons and frequent coffin furniture including nails, handles and decorative brass studs.

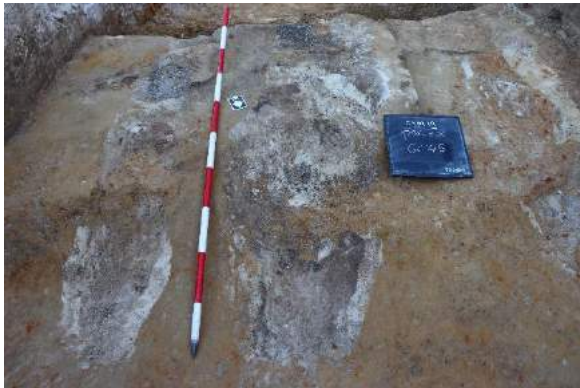
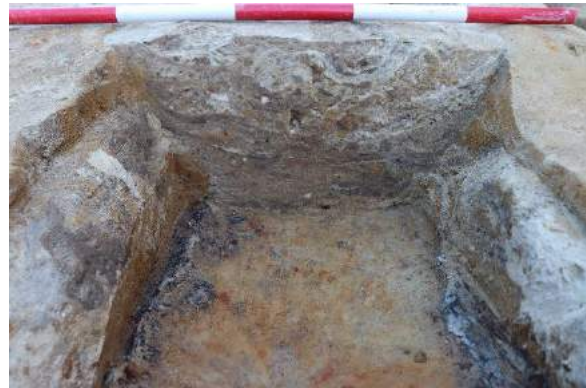
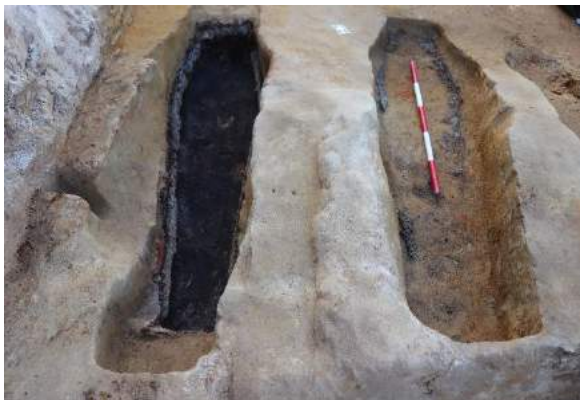
Figure 62: Pre excavation of Grave 45 showing grave cut identified below redeposited sand

The graves ranged in size and depth and had a range of archaeological material found within them, including skeletal remains, coffin remains, ceramic, glass and metal. Grave cuts were evident below the layer of redeposited sand and cut into the natural dune profile. Graves have been subdivided into three categories: unexhumed, exhumed, and indeterminate. The status of the grave was determined by a list of identifiable features – in some instances there was too much disturbance to determine its true nature.

During the salvage excavations within the former Congregational Cemetery, nine unexhumed or partially unexhumed human burials were uncovered. Grave 46 identified the intact remains and name plate belonging to Joseph Thompson. No other legible name plates were found and therefore Grave 46 was the only burial that had a definitive association with the interred remains. The unexhumed graves were primarily identified on the basis of reasonably articulated *in situ* human remains. Generally, the skeletal remains were poorly preserved. Whether the partially preserved portions of skeletal remains are due to soil quality or partial exhumation is yet to be determined. This will be further discussed in the final excavation report.

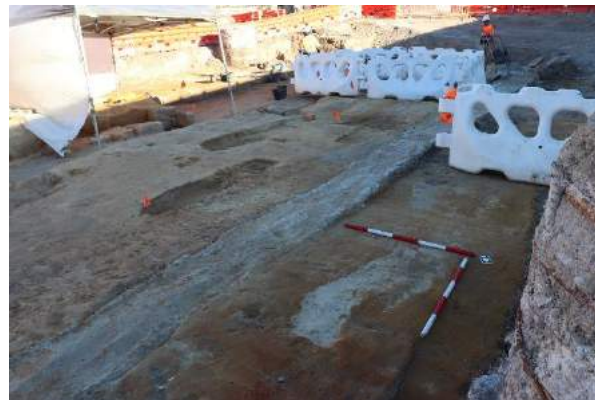
Figure 65: Pre excavation of indeterminate Grave 35 showing same orientation to other graves

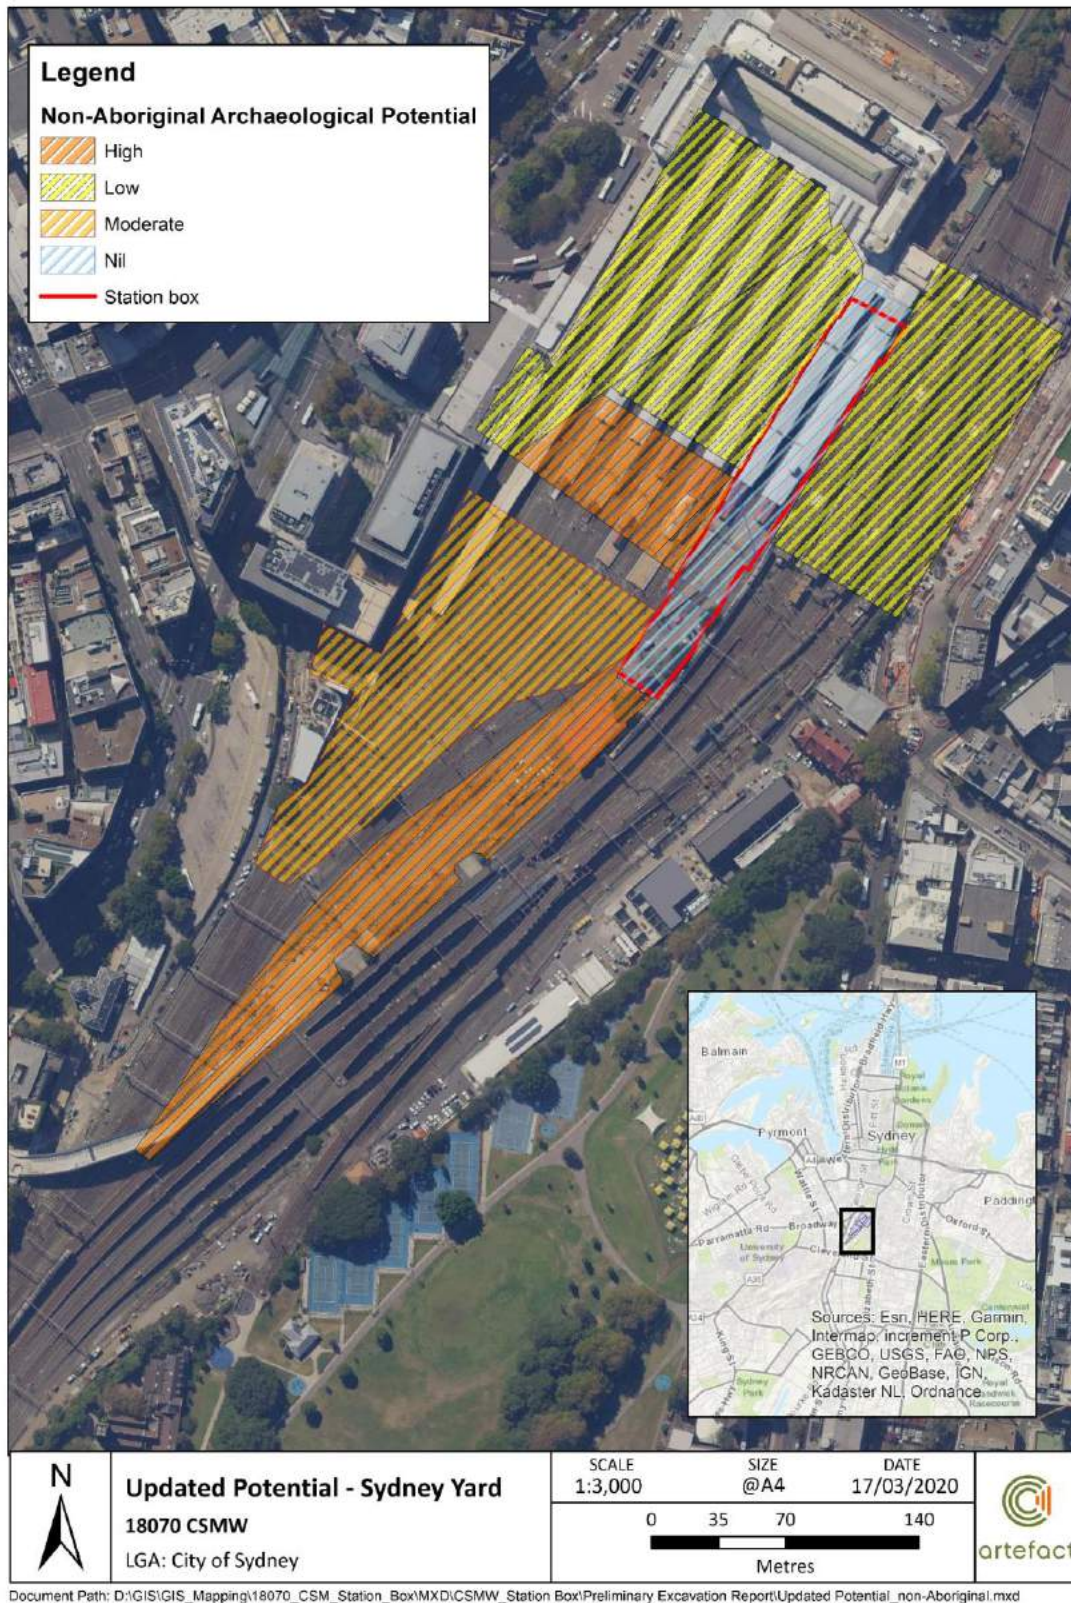
Figure 66: Sydney Yard, Central Station updated non-Aboriginal archaeological potential map

It is now considered there is a moderate to high potential to find intact archaeological remains in Sydney Yard. No further archaeological resources would be found within the location of the station box area as these have been archaeologically salvaged as part of the CSMW (Figure 66 and Figure 67). The revised archaeological potential as a result of the CSMW archaeological program is summarised below.

Non-Aboriginal archaeological potential (Figure 66):
