Construction Biodiversity Management Plan

Sydney Metro City and Southwest, Central Station Main Works Project Construction Biodiversity

Project name	Central Station Main Works
Client	Sydney Metro City & South West – Sydney Metro
Client contract number	CSMW
Laing O'Rourke contract number	K51

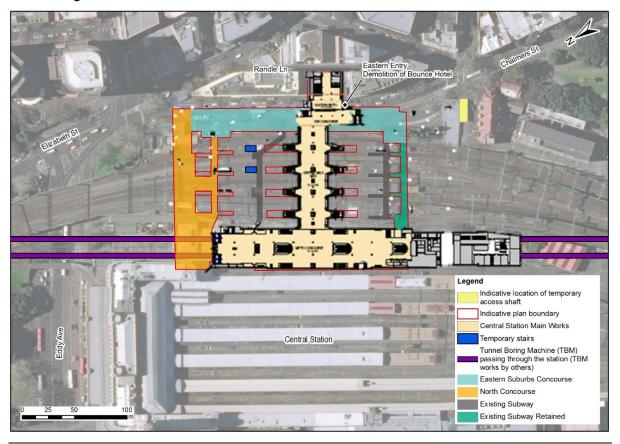
Figure 1.1: CSMW Project Works

- Suburban platforms refreshing
- Station excavation requiring the removal of approximately 230,000 cubic metres of spoil
- · Demolition of the 'Bounce Hostel'
- Construction of the new eastern pedestrian portal, the Central Walk and related station access arrangements to existing platforms.

Refer to Figure 1.1 below for the locations of the works.

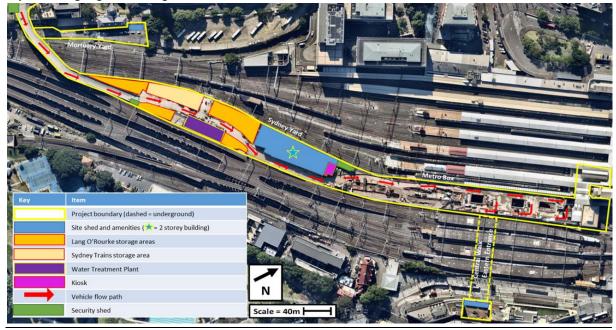
Figure 1.3: Project Site

It should be noted that there are only 11 trees within the CSMW rail corridor, and these will all require removal due to the highly constrained nature of the site. The Project location and site layout is highlighted in Figure 1.3 below.

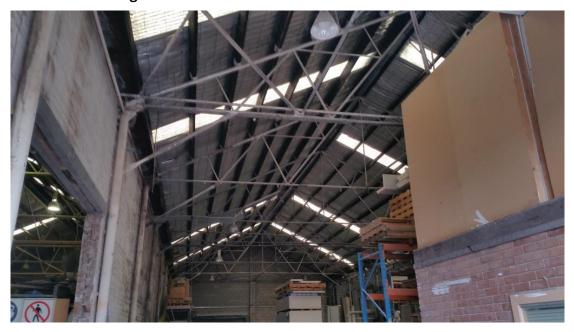
Plate 4 Buildings at Waterloo Station. All are identified as 'non-threatened microbat habitat'

The microbat habitat inspection interim report (Biosis 2017) identified a number of buildings within the construction areas at Waterloo Station and Marrickville Dive Sites provide roof cavities, which may be used as roost habitat for non-threatened microbats. The following measures are recommended to mitigate potential impacts to non-threatened microbats, during demolition of buildings in the areas identified in Appendix 2: Figure 2 as 'non-threatened species habitat':

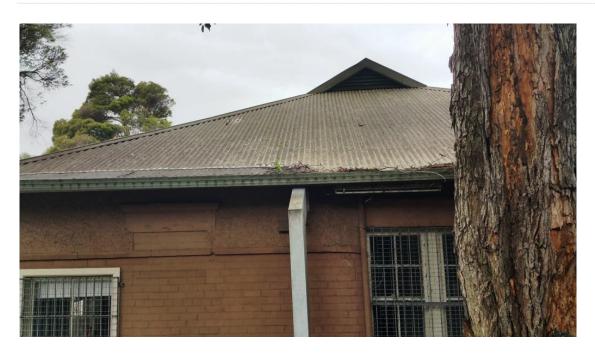
Plate 5 Buildings at Marrickville Dive Site without roof cavities
